# MOULD AND MOISTURE ASSESSMENT

Client Name: **Mitchell Watts**  
Street: **9 Wildthorn Avenue**  
Suburb: **Dural**  
Postcode: **2158**  
Assessment Date: **Friday 27th March 2026 10:00am**

Conducted by: **Joanne Lia - Principal Building Biologist**  
**NoToxRox Building Biology Services**  
[info@notoxrox.com](mailto:info@notoxrox.com)  
[notoxrox.com](http://notoxrox.com)  
**0411 478 716**

NoToxRox Building Biology Services was engaged by the prospective purchasers of 9 Wildthorn Avenue, Dural NSW 2158 to conduct a pre-purchase mould and moisture assessment. The inspection was undertaken on Friday 27th March 2026.

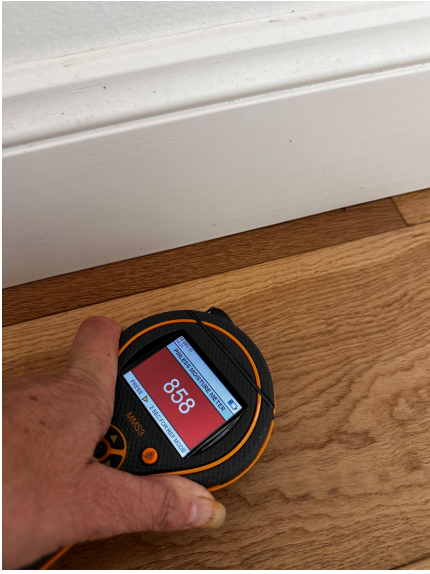
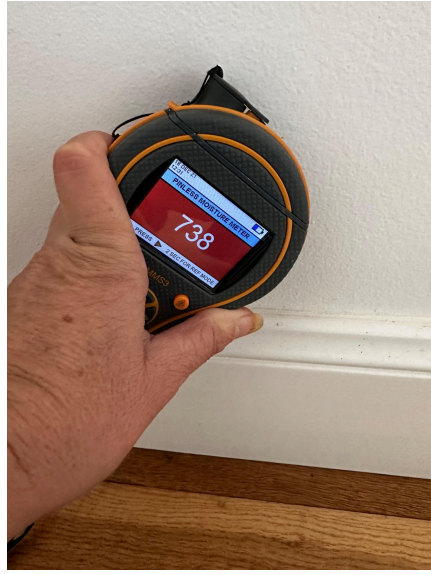
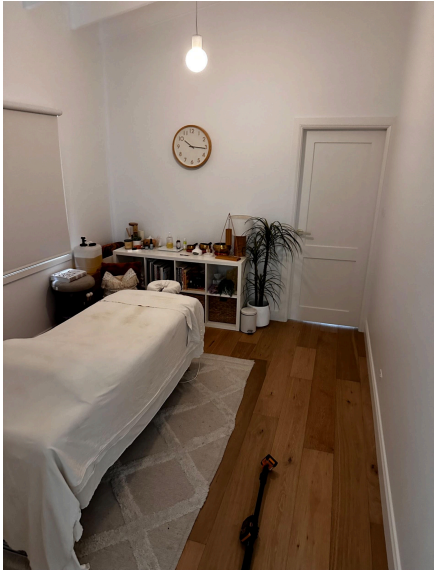
<p>Elevated moisture readings were recorded beneath the timber floorboards adjacent to the external wall. This wall is located below ground level, increasing the likelihood of moisture ingress or lateral damp transfer.</p>	<p>Elevated moisture was detected along the base of the wall, extending horizontally along the wall line. Under the window, increased readings were noted from floor level up to approximately 1 metre in height</p>	<p>Overview of the massage room showing its below-ground position and proximity to the external wall where elevated moisture levels were identified.</p>
<p><b>MESSAGE ROOM</b></p>

The lower massage room and office, along with the entrance area, are all located along adjacent to the external pond and below-ground wall sections. Moisture mapping and thermal imaging confirmed elevated moisture levels within these walls and floor junctions. The building configuration, including below-ground construction, high external ground levels, garden beds, and the presence of a large body of water immediately adjacent to the structure, is creating sustained moisture loading against the building envelope. This is consistent with the elevated indoor humidity readings and supports the conclusion that the building materials are retaining moisture and contributing to ongoing mould growth.

To make these rooms suitable for regular use, significant works would be required to address the underlying moisture sources. This would likely involve improvements to external drainage, potential excavation to reduce ground levels against the building, and reconfiguration of the pond or surrounding landscape to reduce hydrostatic pressure against the wall. Additional building works may also be required to improve waterproofing and drying potential of the affected wall assemblies.

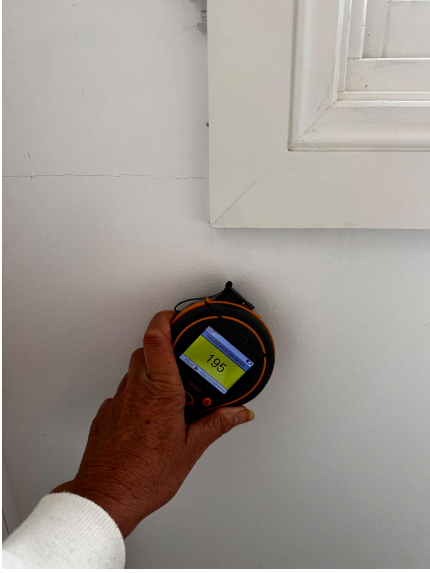
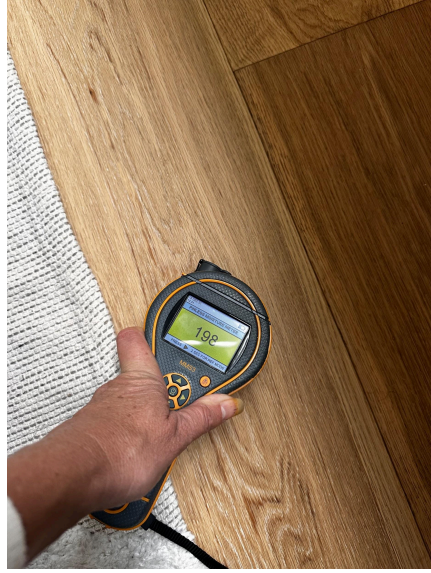
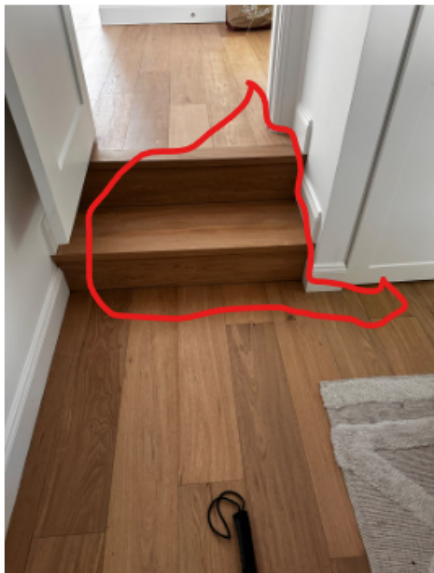
<p>Moisture readings to the wall surface adjacent to the window were within normal limits, with no elevated moisture detected at the time of inspection.</p>	<p>Moisture readings to the timber flooring in the adjacent area were within acceptable ranges, indicating no widespread moisture impact beyond the previously identified wall zone and adjacent floorboards.</p>	<p>Elevated moisture was detected in the area marked in red.</p>

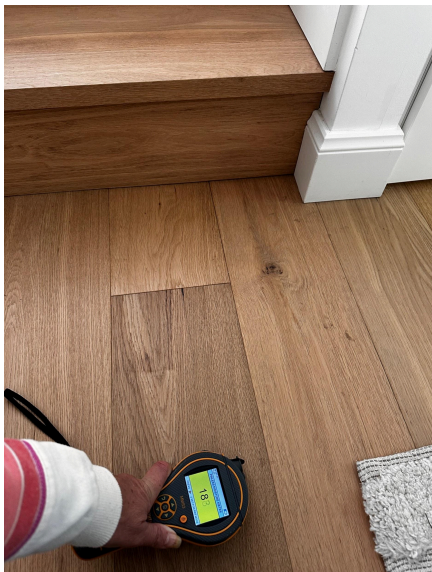
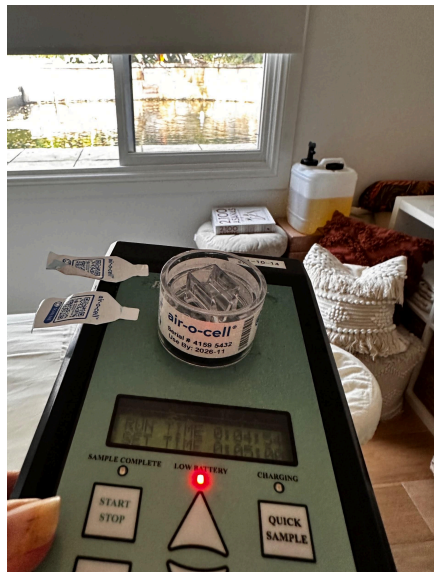
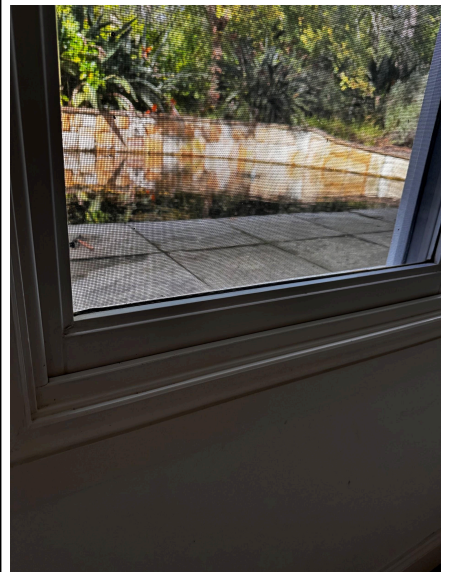
**MESSAGE ROOM**

Normal moisture readings were detect towards the centre of the room

An air sample was taken from this room

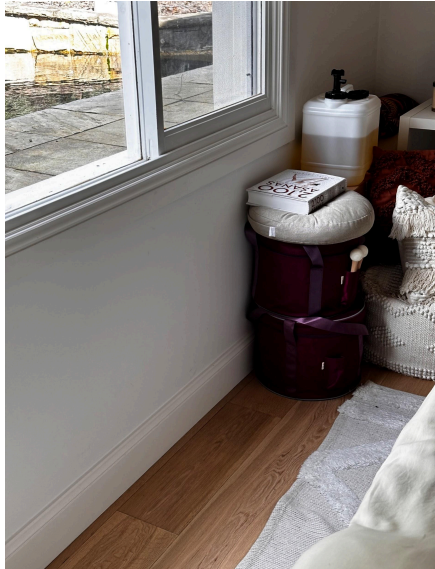
MASSAGE ROOM

<p>Visible mould was seen growing on the rattan baskets in Massage room</p>	<p>Thermal imaging of the external wall shows a cooler area to the lower section of the wall and corner junction,</p>	<p>consistent with moisture presence or reduced thermal performance in this below-ground wall section.</p>

*Chaetomium* was detected within the lower massage room sample. This genus is widely recognised as a water damage indicator and is typically associated with prolonged moisture exposure and cellulose-based materials. Its presence confirms that the area has been subject to chronic damp conditions. *Torula* was detected in the entrance sample and also in the outdoor control. *Torula* is not considered a primary water damage indicator but is commonly associated with damp environments and decaying organic matter. Its presence indoors, particularly in combination with elevated *Aspergillus*/*Penicillium* levels, still supports the presence of moisture-related conditions.

Based on the findings, the lower massage room and office are considered to be Condition 3 environments under the ANSI/IICRC S520 standard, indicating active mould growth. The entrance area is likely a Condition 2

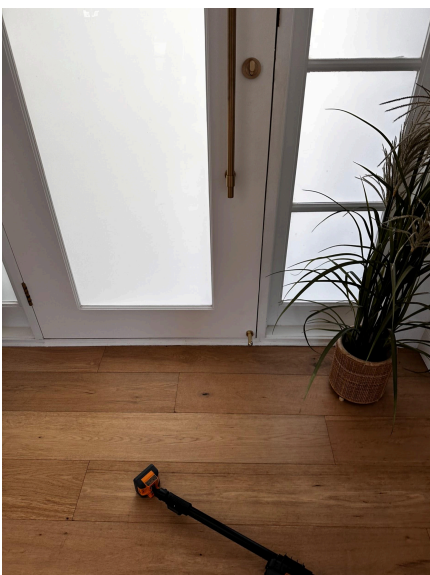
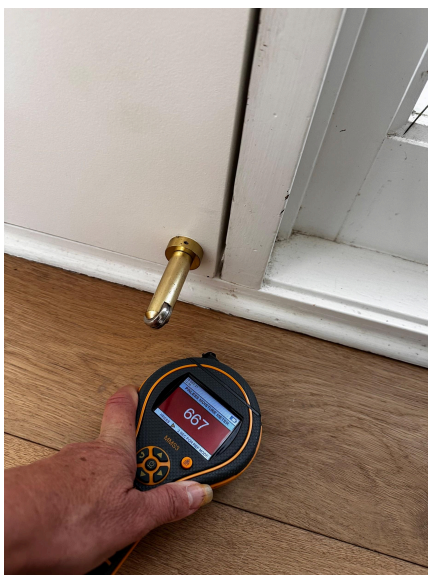
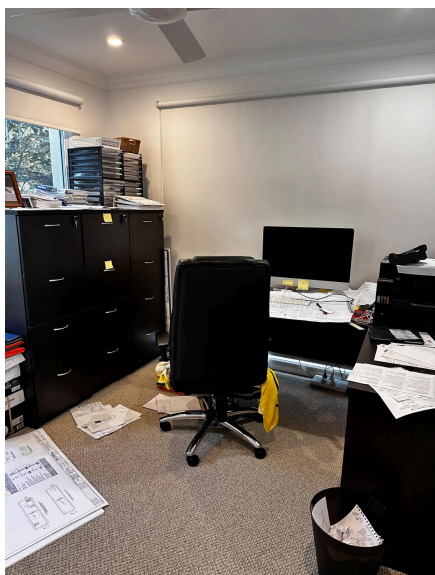
ENTRANCE		OFFICE

<p>Elevated moisture was also detected around the entrance at the front door. There was a slight musty odour here</p>

A musty odour was noted at the entrance and externally near the pond area, which was not fully reflected in the spore trap results. This suggests the likely presence of microbial volatile organic compounds (mVOCs), which are gases released during active microbial growth. mVOCs are not captured in spore trap sampling and can often be detected by odour even when airborne spore counts are only moderately elevated. This supports the conclusion that microbial activity is occurring within building materials or concealed areas.

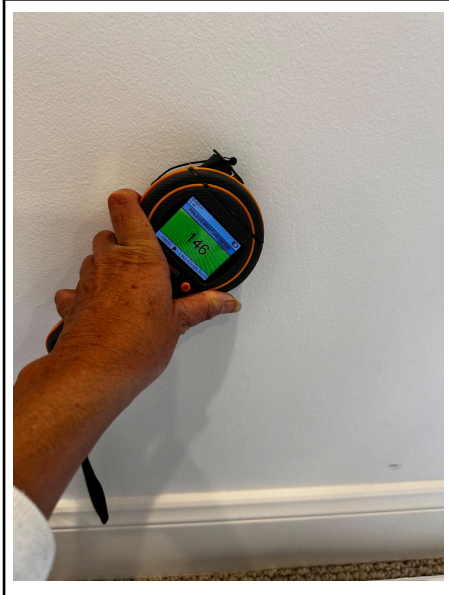
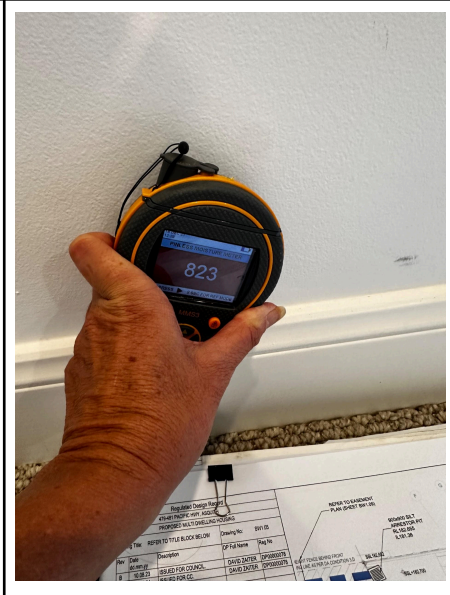
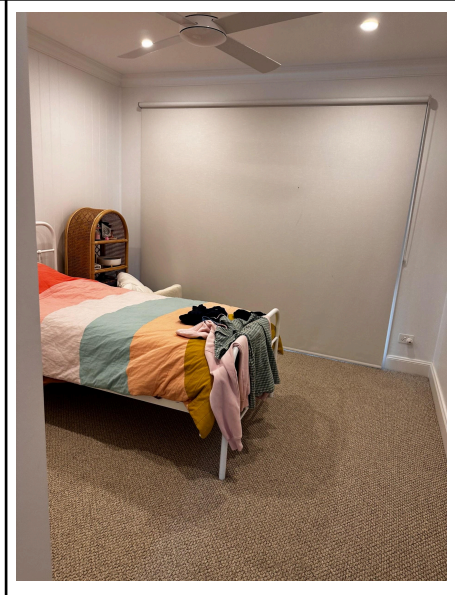
OFFICE		BEDROOM

<p>Normal moisture readings were detected throughout the office upper walls, floor and ceiling.</p>	<p>Elevated moisture was detected along the base of the external wall in the office. This area backs on to the pond outside.</p>

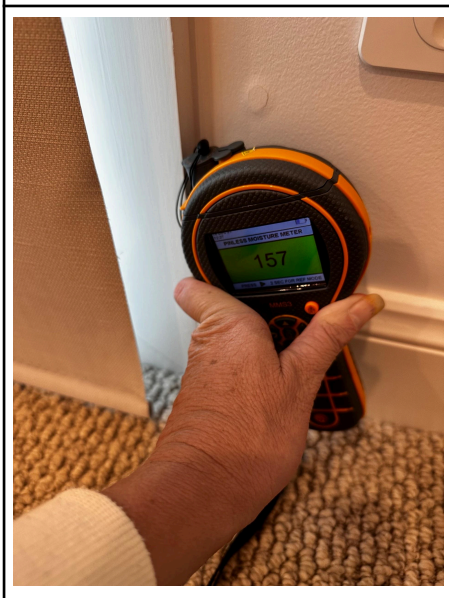
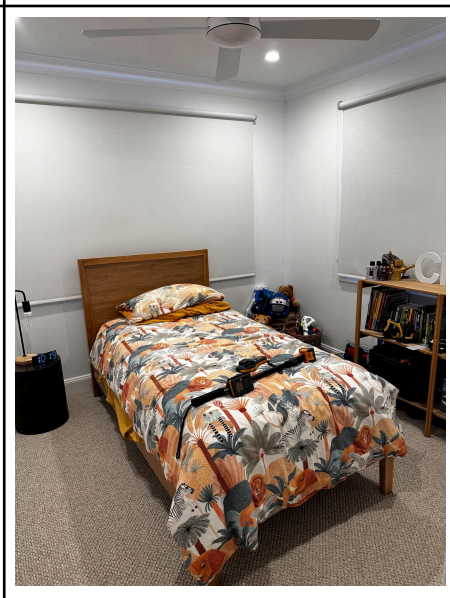
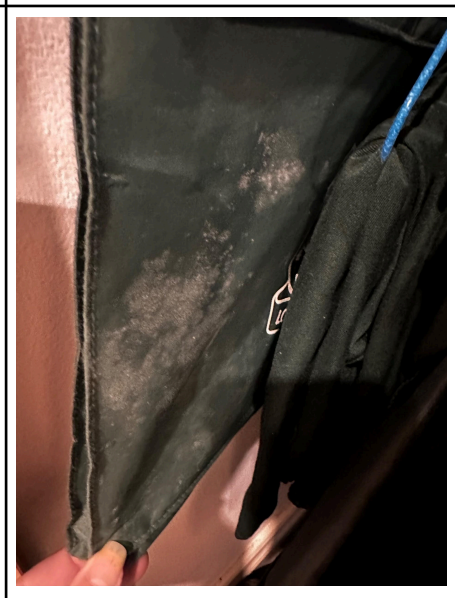
BEDROOM	BEDROOM

<p>Normal moisture readings were detected throughout this bedroom</p>		<p>Mould was found on some items of clothing in the cupboard in this bedroom</p>

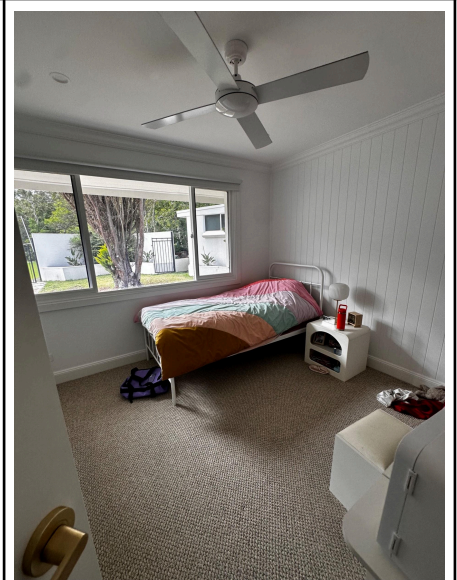
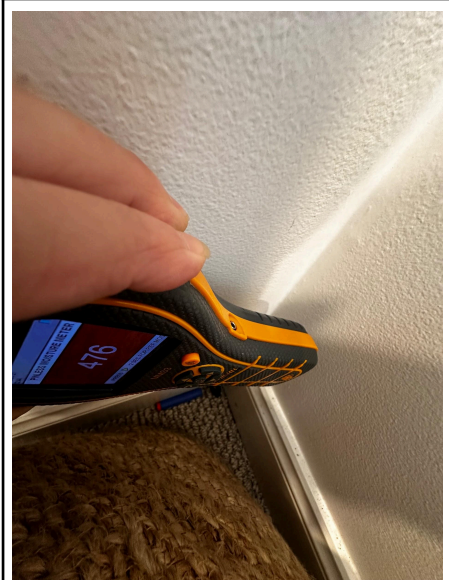
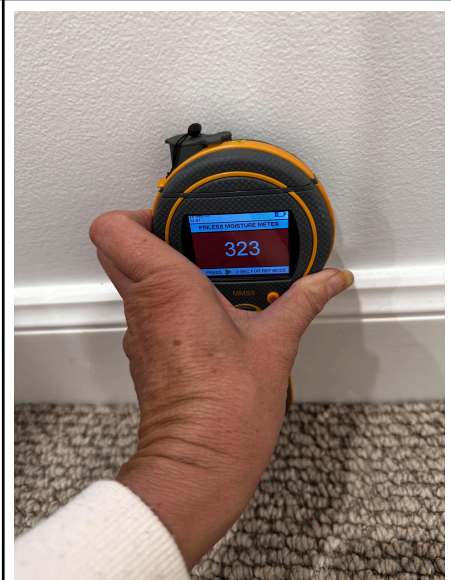
<p><b>BEDROOM</b></p>

<p>No elevated moisture was detected in this bedroom</p>
<p>However elevated moisture levels were detected at the base of the walls in this bedroom indicating rising damp.</p>

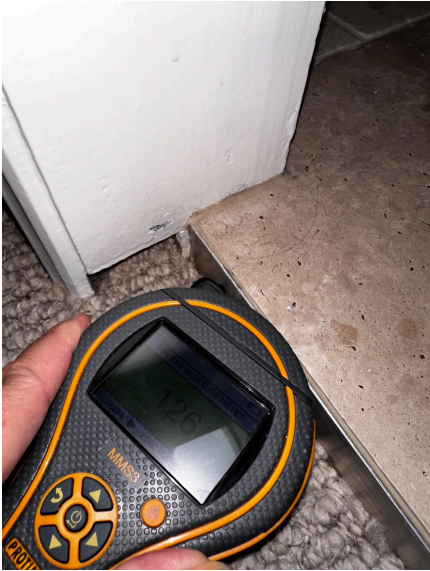
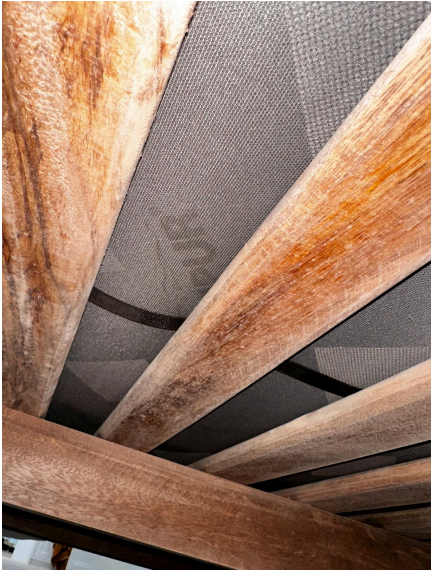
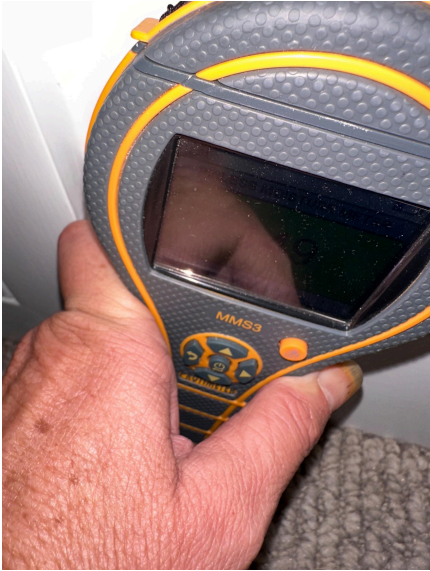
MASTER BEDROOM

Normal moisture ratings beneath the carpet.	Suspected mould growth on the underside of the bedroom slats in the master bedroom. This is usually due to chronic high humidity	Normal moisture readings at the base of the external wall. No sign of rising damp in this room.

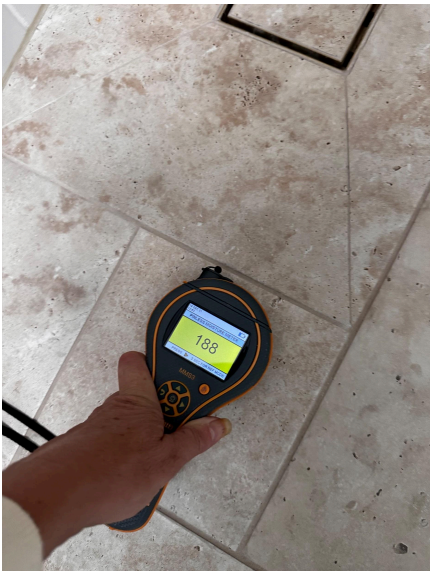
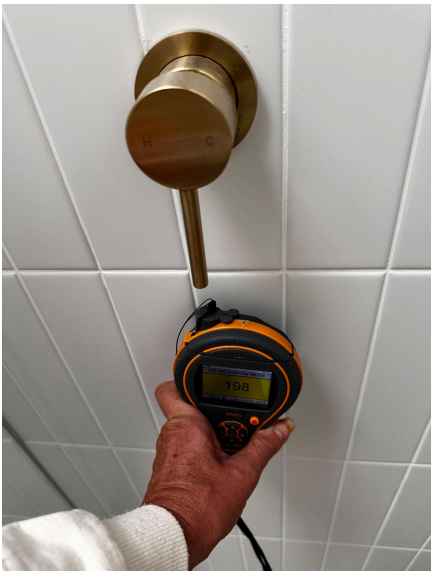
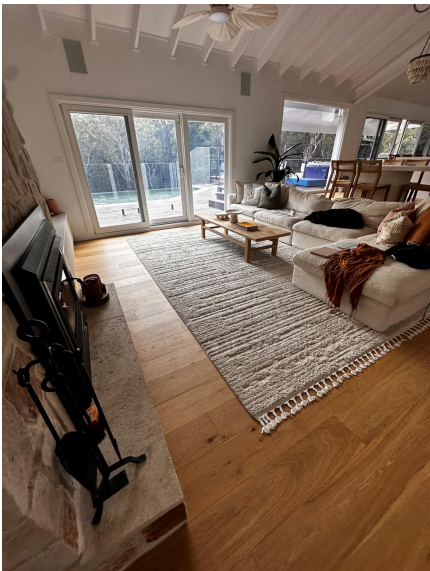
ENSUITE	LIVING ROOM

There were no signs of elevated moisture throughout any of the bathrooms

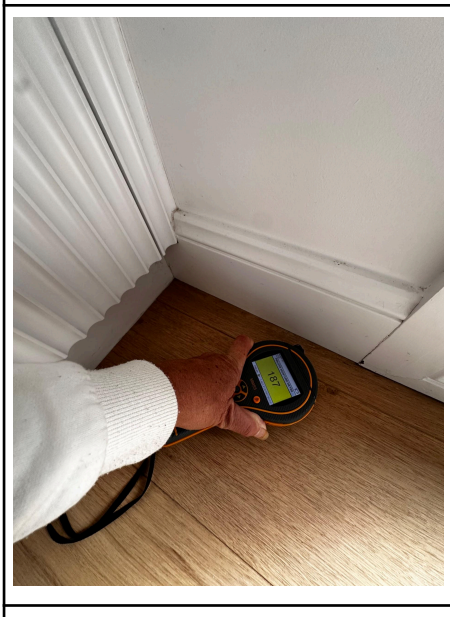
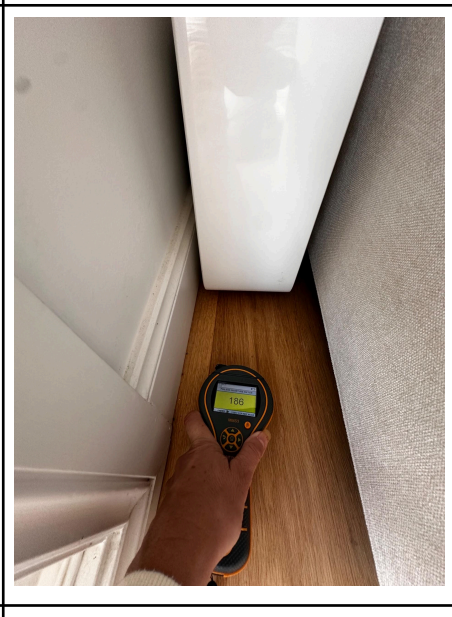
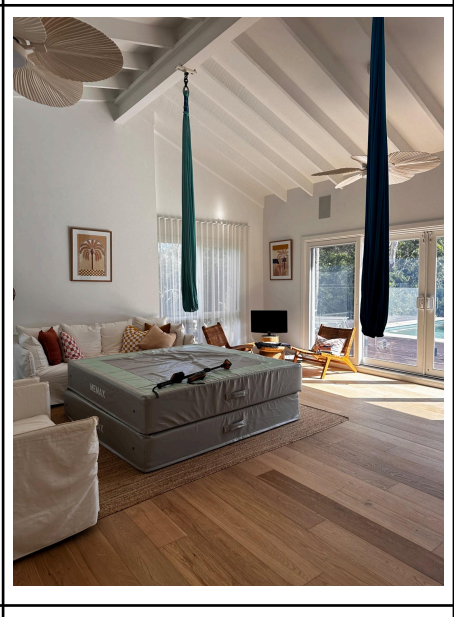
<b>LIVING</b>		<b>FAMILY (AERIAL ROOM)</b>

<p>Normal moisture readings were detected throughout the rest of the living room</p>		<p>No elevated moisture was detected throughout the aerial room.</p>

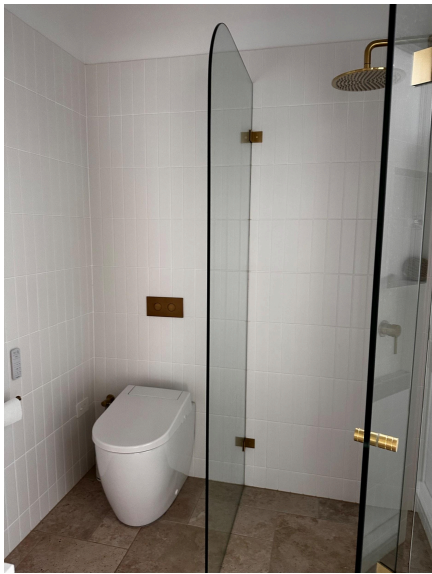
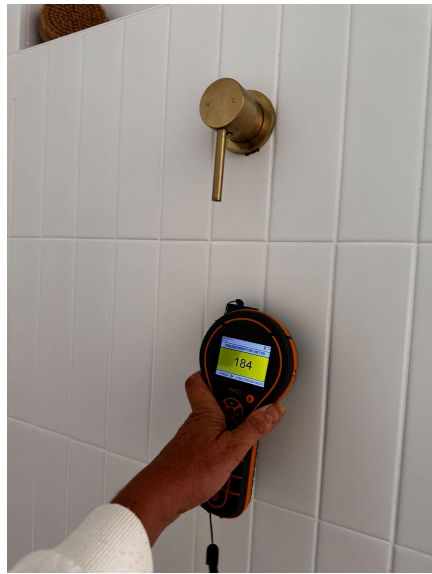
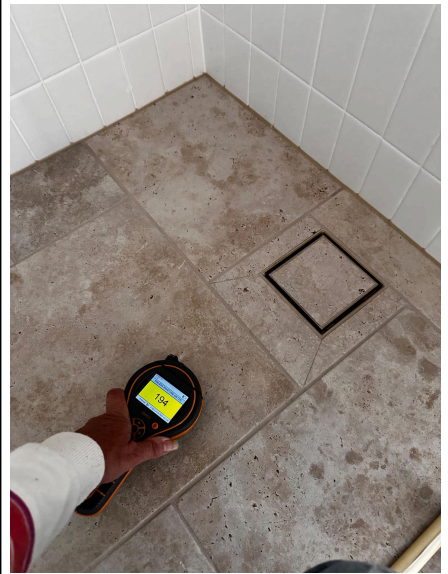
**BATHROOM**

All the wet rooms had normal moisture readings.

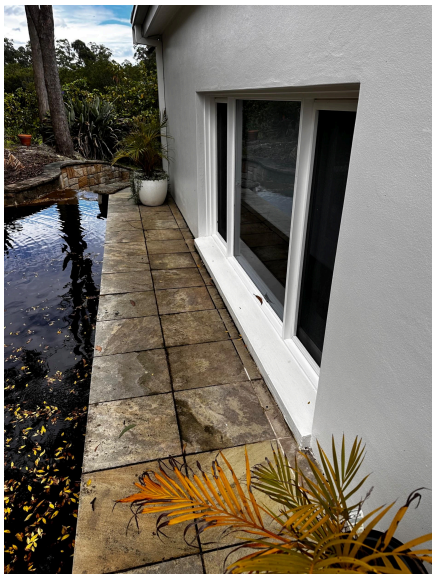
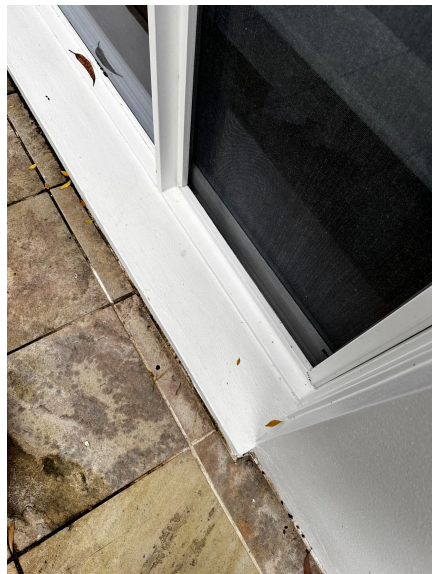
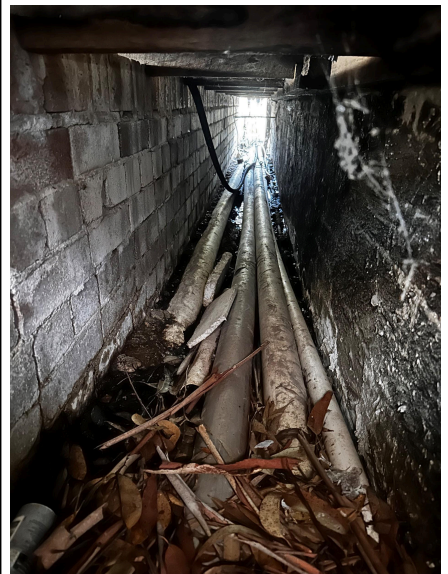
**OUTSIDE**

External view of the massage room wall showing the adjacent pond and paved area. The external ground level is higher than the internal floor level of the room, placing this wall below ground and increasing the risk of lateral moisture ingress.

Detail of the external wall and window base. The paving is installed directly against the wall with limited visible clearance, which may restrict drainage and contribute to moisture accumulation against the building envelope.

Subfloor/drainage view beneath the external paving adjacent to the massage room. While drainage infrastructure is present, the area remains below ground level and shows signs of debris and moisture exposure, which may limit effective water movement away from the wall and contribute to ongoing damp conditions internally.

<p>External pond located directly adjacent to the massage room. The large, retained body of water in close proximity to the building increases local ground moisture levels and hydrostatic pressure against below-ground wall.</p>	<p>Closer view of the pond edge and planting area directly abutting the external wall of the massage room. Water levels are in close contact with the retaining structure, contributing to a persistently damp environment along this wall.</p>	<p>High moisture reading recorded to the external wall surface (607 REL)</p>

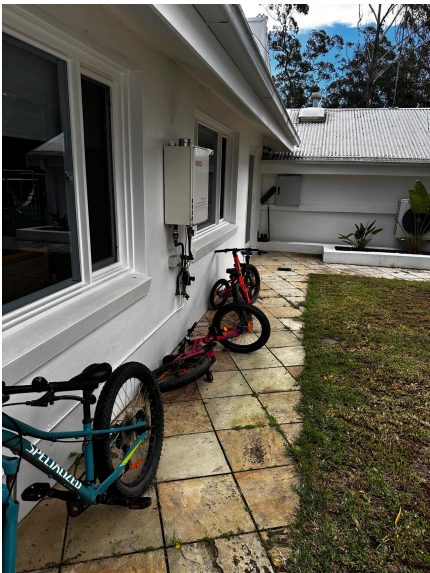
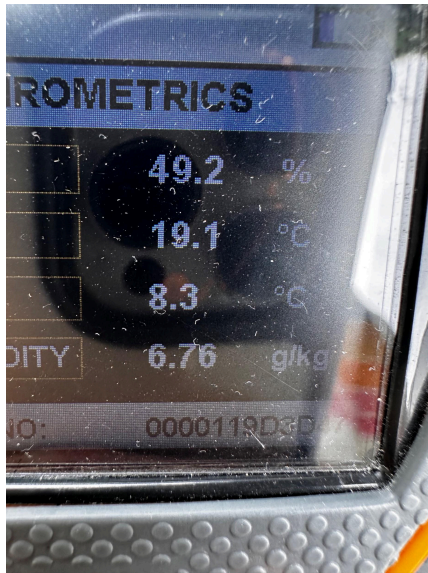
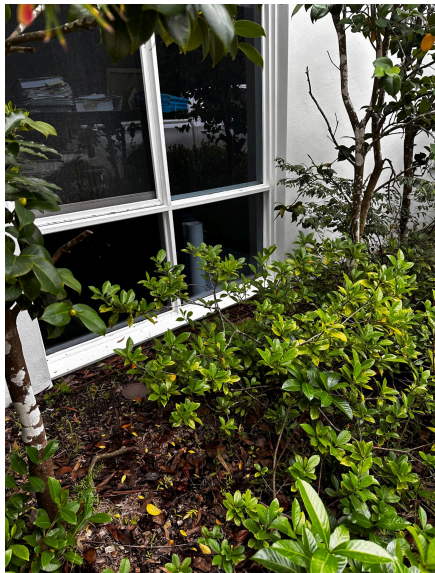
<p><b>OUTSIDE</b></p>	<p>Outdoor Temp 19.1°C RH 49.2%</p>

<p>External view of the opposite elevation of the dwelling. This side of the building is above ground level with adequate clearance and drainage.</p>	<p>These conditions are within normal ranges. Compared to, indoor readings which were notably higher, indicating that moisture is being retained within the building materials.</p>	<p>Garden bed located adjacent to the external wall. Vegetation and soil are positioned directly against the building envelope, which can contribute to increased moisture load and reduced drying potential along the wall.</p>

<p>Garden bed and paving in close proximity to the building. Ground levels remain relatively high against the wall, limiting drying potential and contributing to increased moisture load.</p>	<p>Elevated moisture reading (439 REL) recorded to the lower section of the external wall, indicating moisture retention within the wall assembly consistent with lateral damp ingress.</p>	<p>Detail of the external wall junction and paving interface. Limited clearance and drainage at the base of the wall may allow moisture to accumulate against the building, contributing to ongoing damp conditions internally.</p>
