# MOULD AND MOISTURE ASSESSMENT

Client Name: **Mitchell Watts**  
Street: **9 Wildthorn Avenue**  
Suburb: **Dural**  
Postcode: **2158**  
Assessment Date: **Friday 27th March 2026 10:00am**

Conducted by: **Joanne Lia - Principal Building Biologist**  
**NoToxRox Building Biology Services**  
[info@notoxrox.com](mailto:info@notoxrox.com)  
[notoxrox.com](http://notoxrox.com)  
**0411 478 716**

NoToxRox Building Biology Services was engaged by the prospective purchasers of 9 Wildthorn Avenue, Dural NSW 2158 to conduct a pre-purchase mould and moisture assessment. The inspection was undertaken on Friday 27th March 2026.

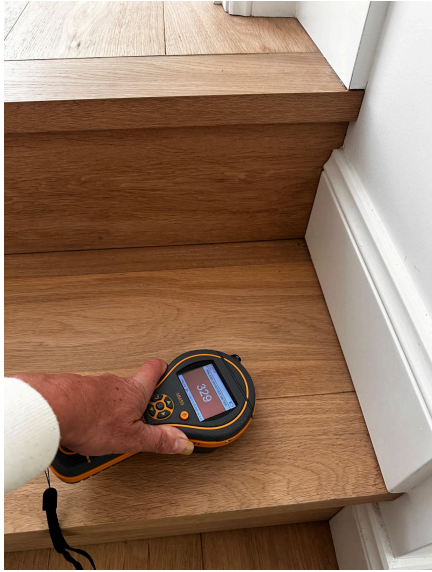
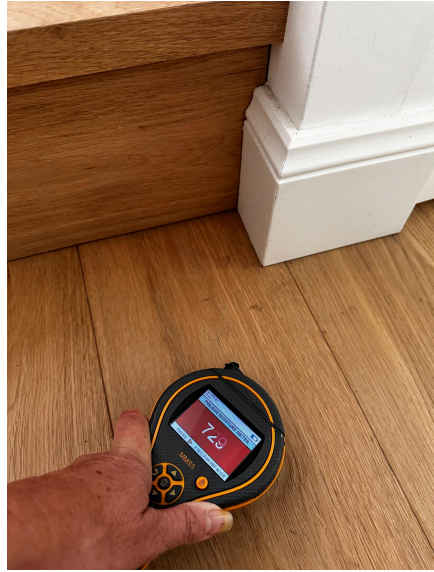
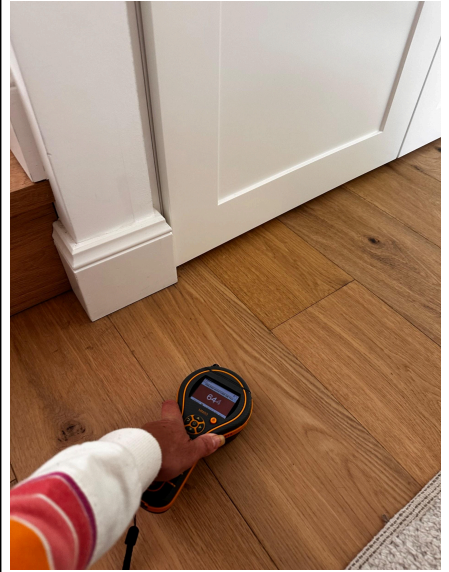
**MESSAGE ROOM**

<p>Moisture readings to the wall surface adjacent to the window were within normal limits, with no elevated moisture detected at the time of inspection.</p>	<p>Moisture readings to the timber flooring in the adjacent area were within acceptable ranges, indicating no widespread moisture impact beyond the previously identified wall zone and adjacent floorboards.</p>	<p>Elevated moisture was detected in the area marked in red.</p>

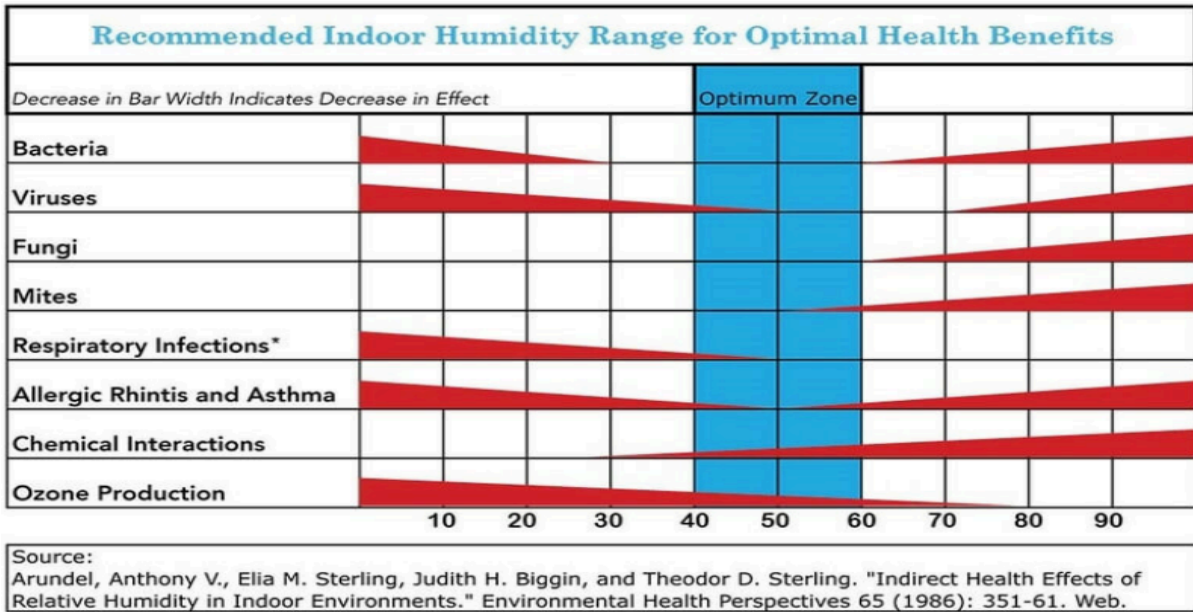
Indoor measurements recorded a relative humidity of 63.5% at 21.8°C, with a specific humidity of 10.33 g/kg. In contrast, external conditions at the time of inspection were significantly lower, with a relative humidity of 49.2% at 19.1°C and a specific humidity of 6.76 g/kg. This indicates that the indoor environment is holding substantially more moisture than the outdoor air, both in relative and absolute terms.

This difference suggests that the elevated indoor humidity is not being driven by external atmospheric conditions alone, but is likely influenced by moisture retained within the building materials and structure. In situations such as this, moisture can accumulate within walls, flooring, or below-ground elements and gradually release into the indoor air, increasing the overall moisture load. Relative humidity levels above 60% create conditions that are more favourable for mould growth, particularly on cooler surfaces where condensation may occur.
